KMP BRAND TECHNICAL BULLETIN

Diagnosing Common Complaints on Cylinder Liners

KB - 15001 PART 2

DIAGNOSING COMMON COMPLAINTS ON CYLINDER LINERS

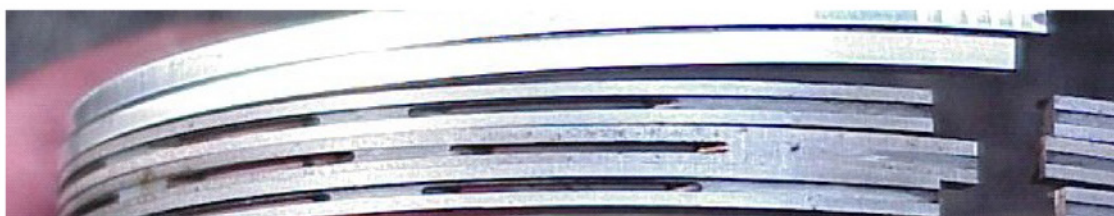
THE RAILS OF THE OIL RINGS HAVE BEEN WORN AWAY, COMPARE THE APPEARANCE WITH A NEW OIL RING SHOWN BELOW

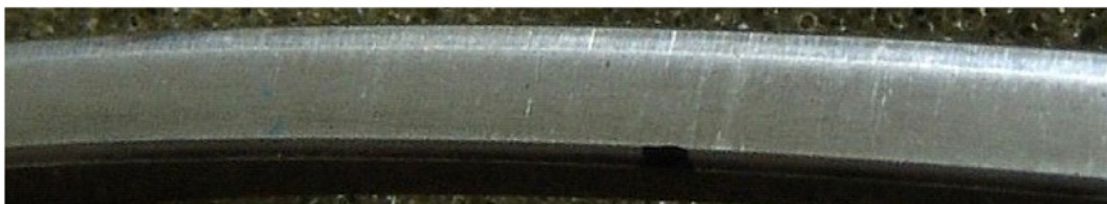
THE FACES OF THESE COMPRESSION RINGS EXHIBIT FINE VERTICAL SCRATCHES

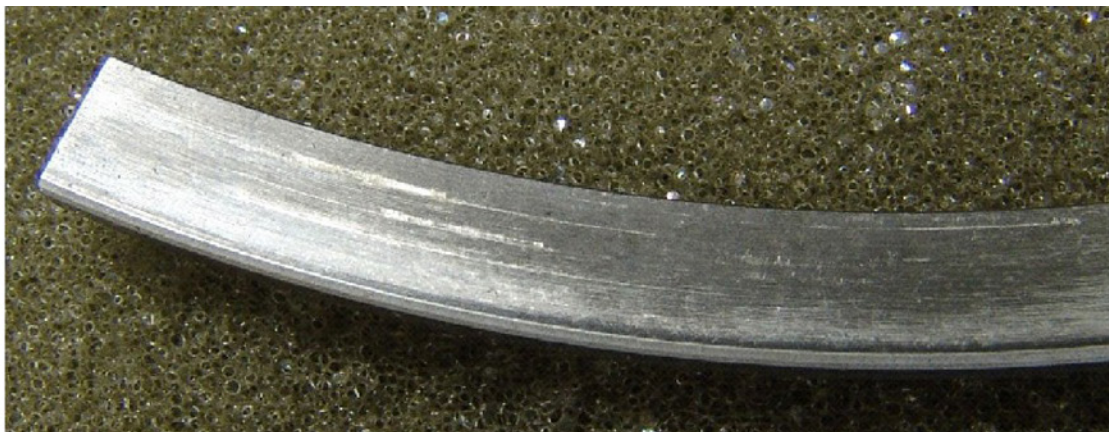
THE SIDE OF THIS COMPRESSION RING HAS BEEN DAMAGED BY CONTAMINATION AS THE RING ROTATED IN THE RING GROOVE IN THE PISTON

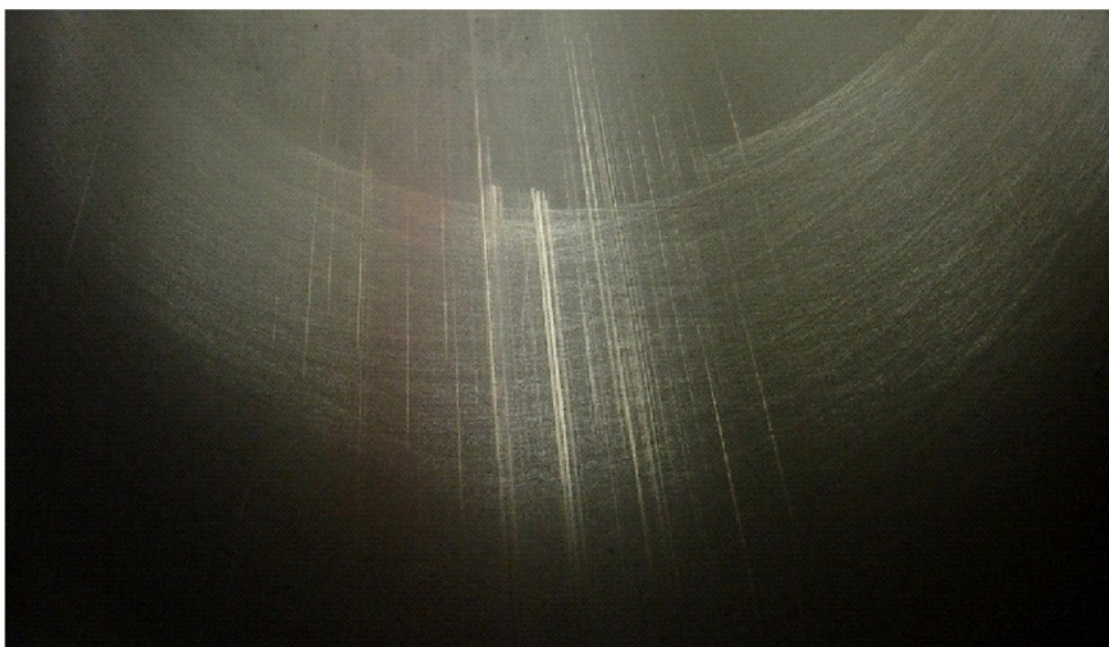
VERTICAL SCORING IN THE BORE OF THE LINER AS THE RESULT OF ABRASIVE CONTAMINATION

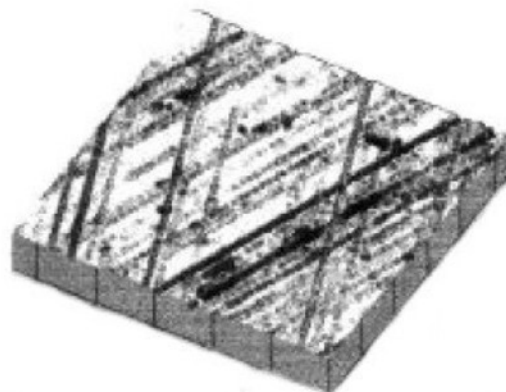
LOW POLISHING

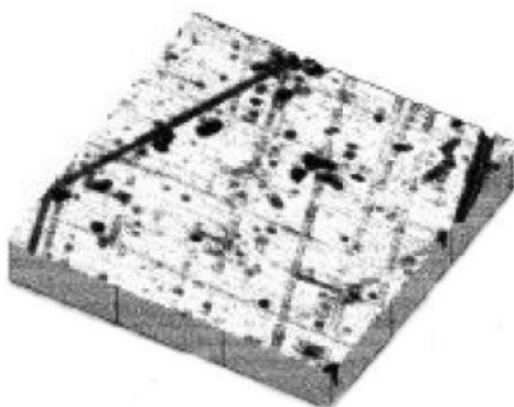
MEDIUM POLISHING

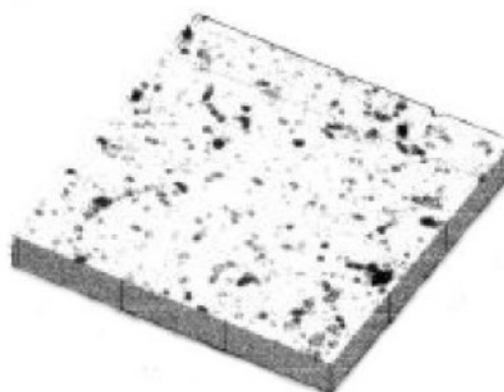
HEAVY POLISHING

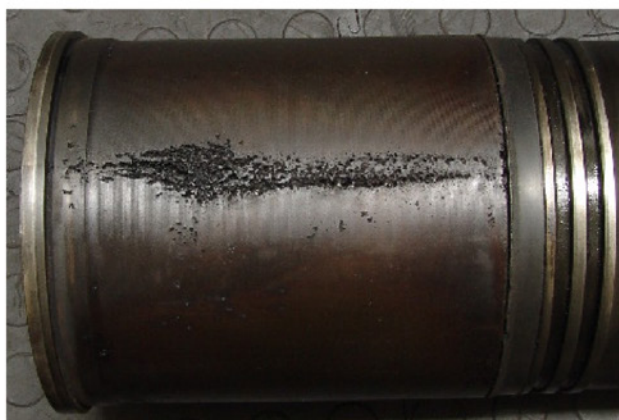
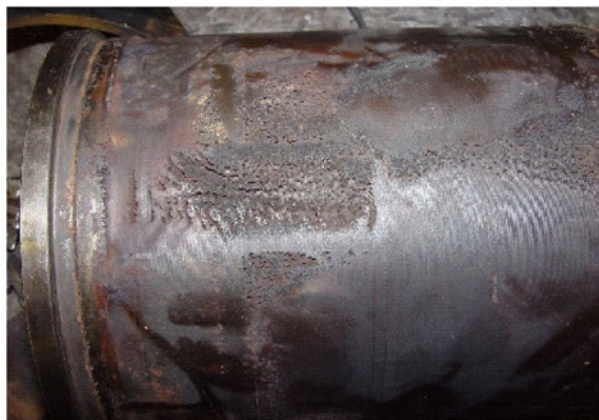
This damage did not occur because the liners were made from an inferior material, it is a phenomenon which has been researched and commented on for decades.

The first step is to maintain a good coolant condition by adding a suitable coolant conditioner, this is offered by KMP against part number 3P2044.

The correct cooling system pressure is also important; it can assist in reducing the amount of air bubbles that will be present in the system – so another important point would be to eliminate any leaks or replace a loose or leaking radiator cap.

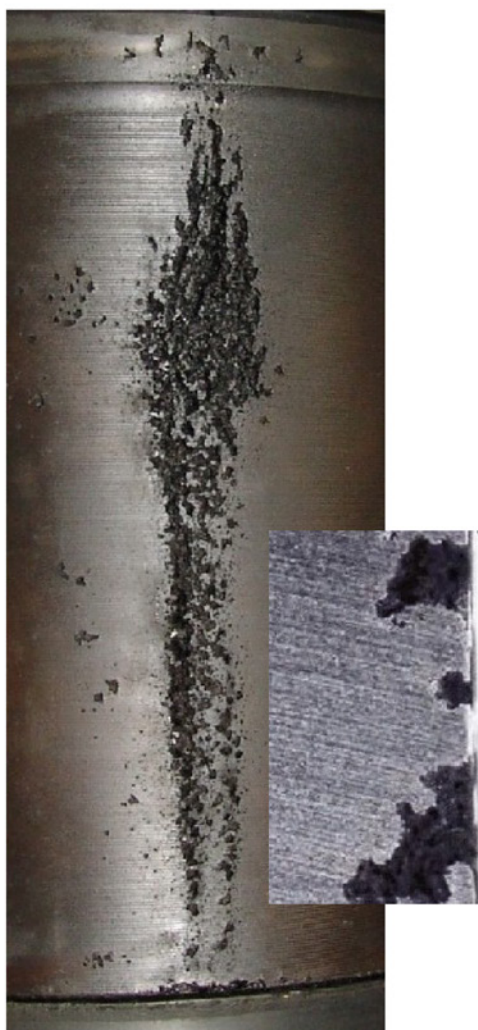
Imagine the disastrous effect if the cavitation perforated through the liner and coolant entered the combustion area – it can happen.

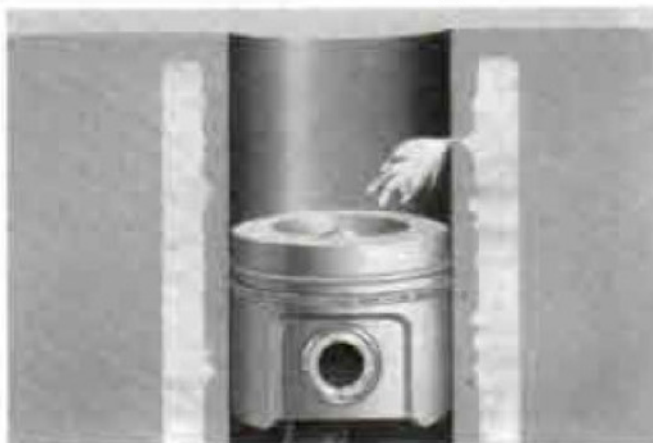
Cavitation erosion is caused by the harmonic engine vibrations which result in the formation of small air pockets between the coolant and the liner (air bubbles) and when they collapse they remove minute particles of the liner.
