KMP BRAND TECHNICAL BULLETIN

Diagnosing Common Complaints on Cylinder Liners

KB - 15001

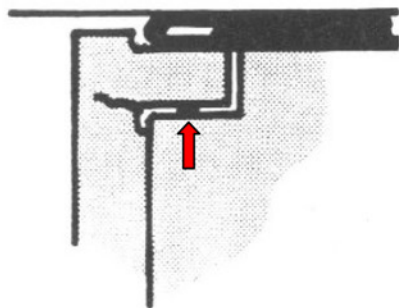
Dirt trapped between the flange and the counterbore

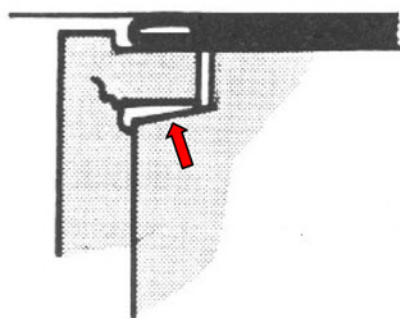
Cylinder block counterbore not square

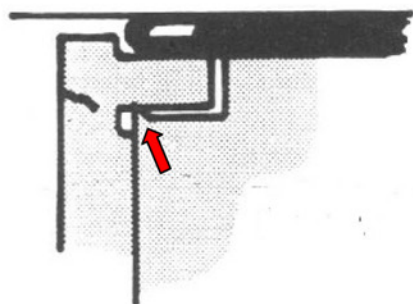
Burr or sharp corner left after the machining of the counterbore

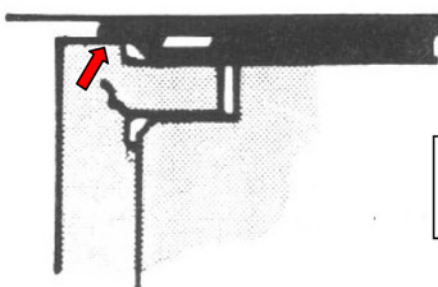
Either the incorrect cylinder gasket used or the gasket incorrectly positioned

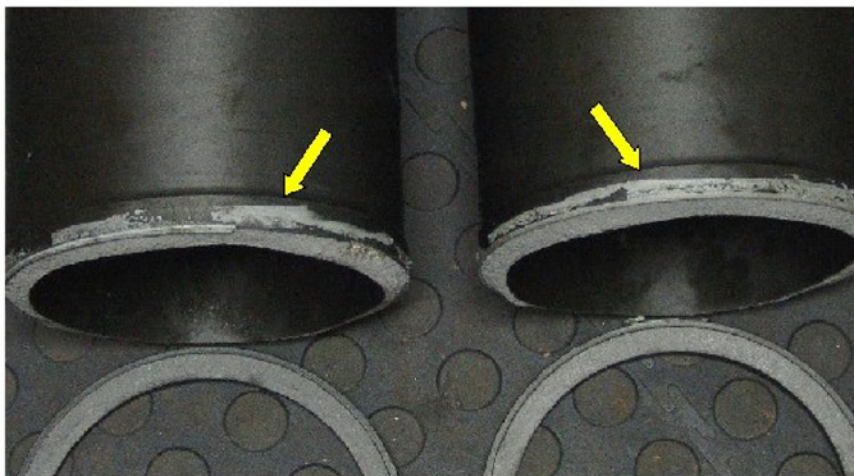
**EXAMPLE 1**

Excessive use of silicone sealant resulted in this failure, the sealant prevented the flange from seating correctly on the deck, and as a consequence liner protrusions were out of specification.

The correct liner protrusion is critical for a successful engine rebuild.

Advisory note, there is a time and a place for the use of silicone sealant, and this is not one of them!!

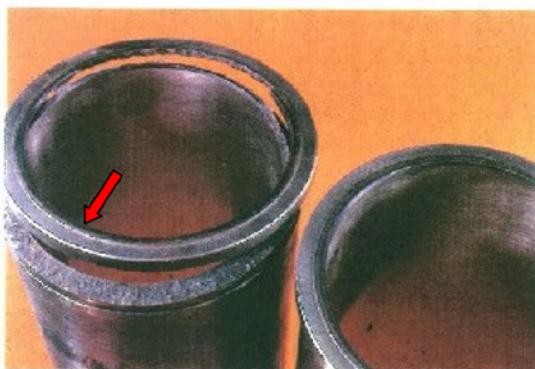
**EXAMPLE 2**

These liners were fitted without a cylinder head gasket which resulted in the cylinder head making direct contact with the liner fire dam.

A similar failure pattern would occur if the liner protrusion was excessive.

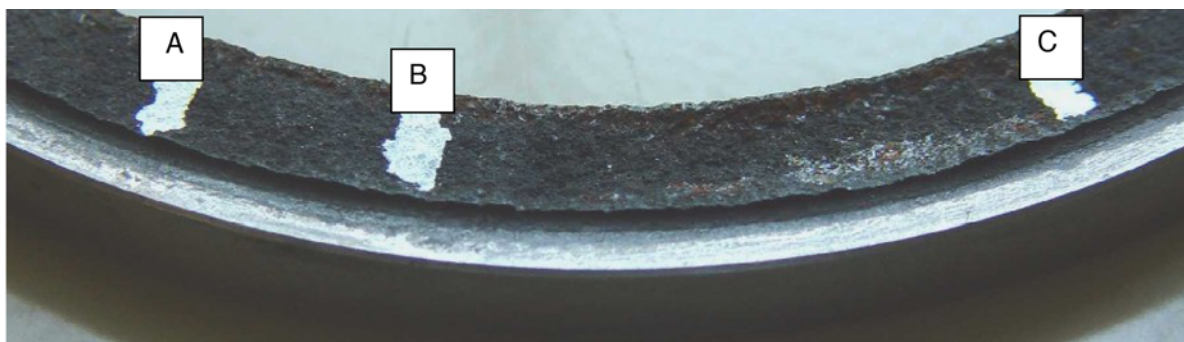
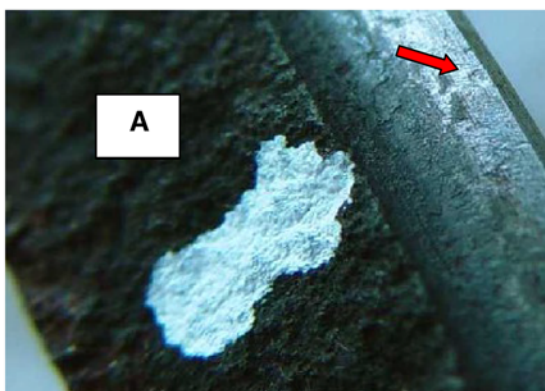
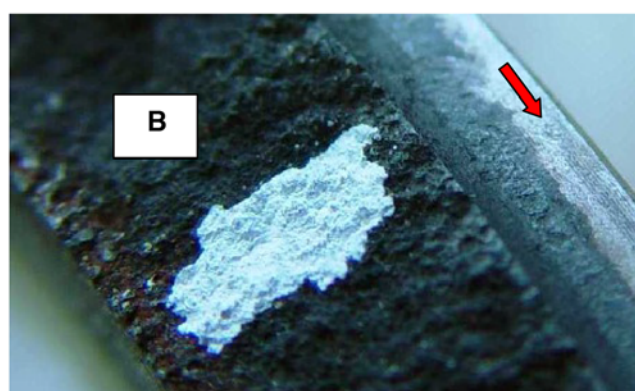
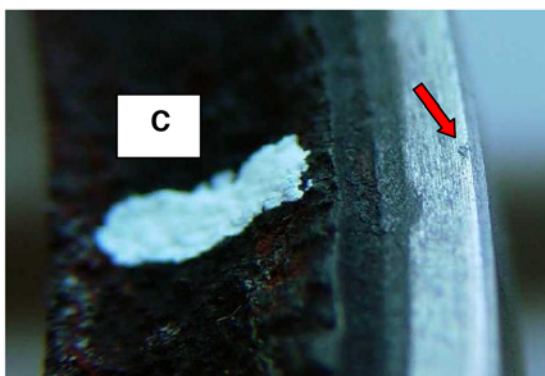
EXAMPLE 3

Debris trapped between the underside of the flange and the area where the liner flange was seated is what resulted in this failure.

The indentations caused by the debris are shown in photographs A, B and C.

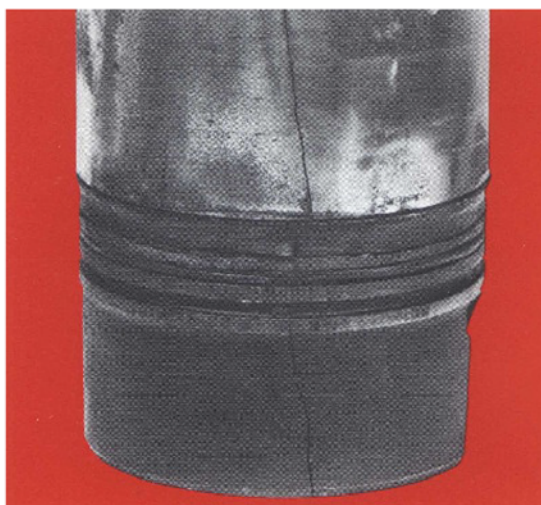
Because the liners are centrifugally cast the grain structure of the material offers considerable resistance to vertical cracking under normal operating conditions. However, rough handling either in transit or at installation can result in a vertical crack either from the flange area downwards or the lower sealing ring area upwards.

Alternatively, vertical cracks can result from either severe cavitation erosion (to be addressed in a later publication) or from piston seizure.

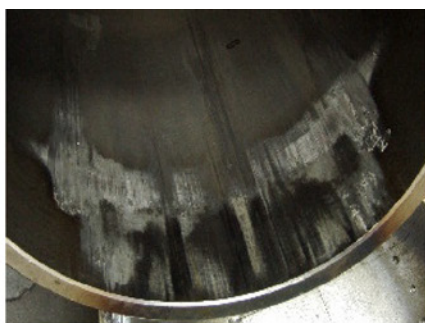
FIGURE 1

One of the final processes during liner manufacture is the vertical honing of the liner bore which achieves a uniform internal diameter from top to bottom. Unfortunately careless installation of the sealing o-rings at the bottom of the liner can result in a complete engine overhaul being wrecked – this contradicts the belief that the rubber o-ring will merely reshape to suit the groove into which it has been fitted. Twisted or rolled o-rings will result in the distortion of the liner bore when the liner is fitted into the block. When the ring is twisted the material in the area of the twist becomes hard and the hardening is further accelerated by the high temperatures which are present during engine operation. The resultant pressures are then exerted on the liner causing distortion and the reduction of the running clearances between the piston skirt and the liner bore, this will then culminate in scuffing. In some configurations the liner also has a crevice seal in addition to the o-rings, and if incorrectly installed this can also result in bore restriction – see figures 1, 2 & 3.

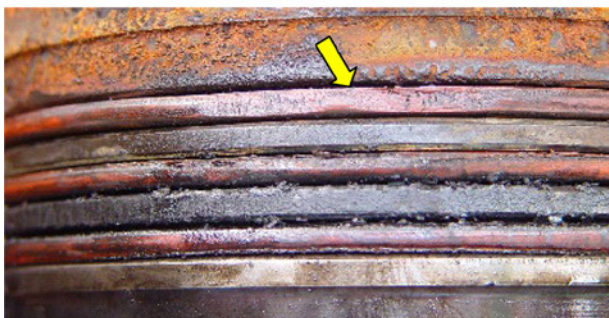
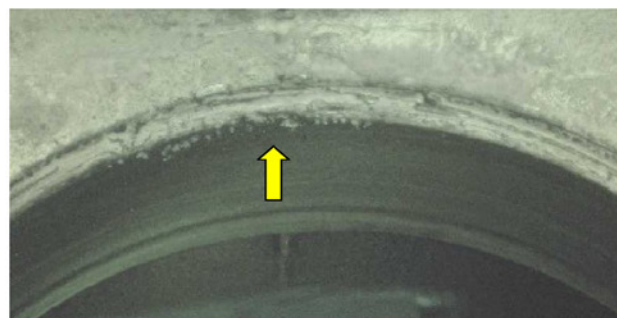
SEAL DAMAGE CAUSED BY POOR CONDITION OF THE LOWER DECK

Make sure the counterbore area is clear of any kind of debris. The lower deck area where the bottom of the liner is located is another very important area and this should also be free of any form of debris or damage.

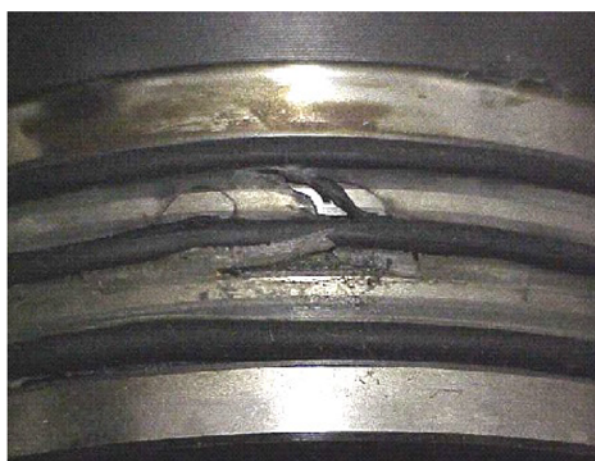
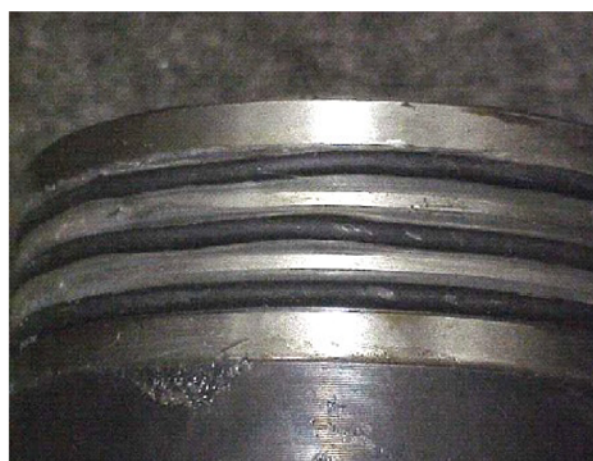
**DESTINED TO FAIL – TWISTED O-RINGS AND
THE UNECESSARY USE OF SILICON SEALER**

The correct method is to install the o-ring seals dry into the liner grooves, this ensures that the seals “bite” into the dry surface and thus prevent them from moving when the liner is installed into the block. Once the seals are in place they must be checked to ascertain that they have not been twisted during installation.

The recommended way to remove any possible twists, is to insert a round rod like a Phillips screwdriver behind the seal and then move it around the full circumference of the seal. The seal “flash” line (see note *) should then be checked and this should run in a continuous straight line around the entire circumference of the o-ring.
