KMP BRAND TECHNICAL BULLETIN

ENGINE BEARING FAILURES PART 2

KB-15002-2

ASSEMBLY ERRORS

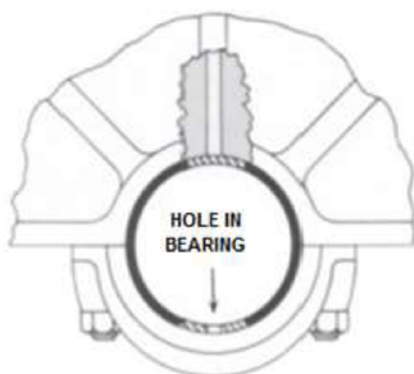
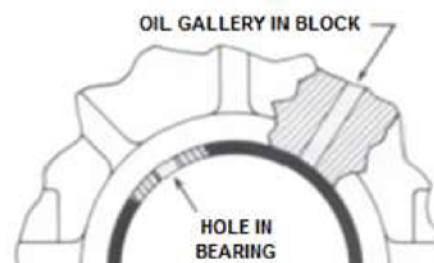
OIL HOLE IN BEARING NOT ALIGNED

In all of the above instances the assembly error will have created an area of abnormal pressure and as a consequence the loss of lubrication will create excessive localised wear in that area. The wear pattern will be very similar to the example shown for "excessive crush".

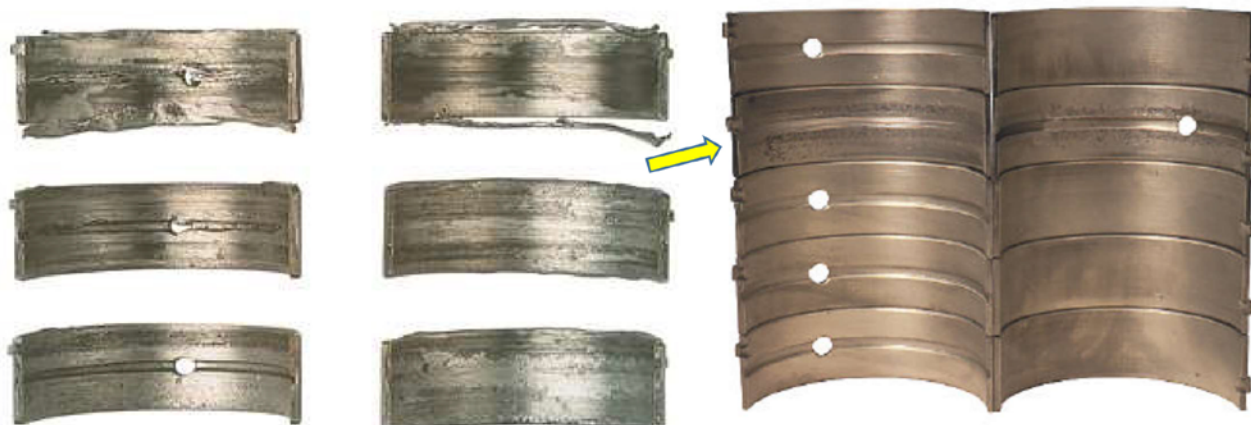
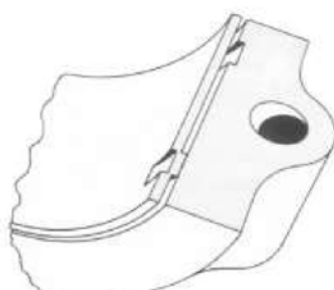
LUG NOT LOCATED CORRECTLY

The illustrations below indicates the resultant damage, note that after one of these failures only one pair of shells sustained damage.

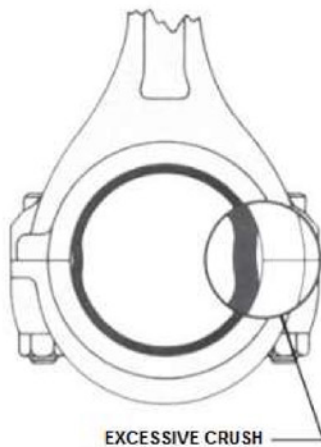
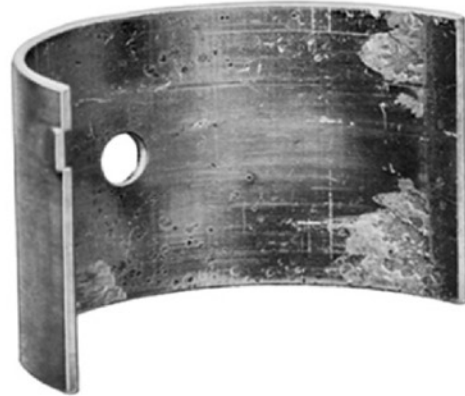
EXCESSIVE CRUSH

When the bearing shell is fitted into its location there is a small amount of material which extends beyond the housing and only when the bearing cap is tightened into position the bearing shells are then forced tightly into the housing; the good contact also creates the necessary heat transfer – so the "extra" material is referred to as the bearing crush.

However, if there is too much crush then the additional material will bulge as indicated above, and this will cause the type of damage shown in the illustration on the right. So what could result in this type of failure ?

Machining had taken place on the mating faces of the housing, either to remove fretting marks or reduce oil clearance, or, the bearing cap fasteners were over-tightened at assembly.

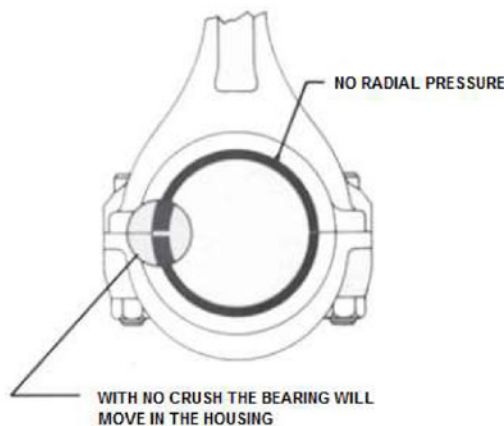
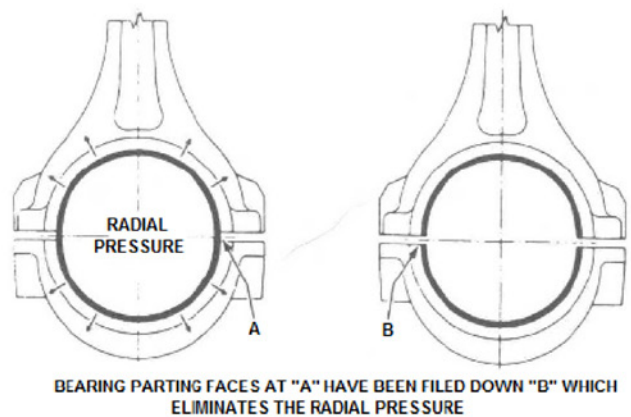
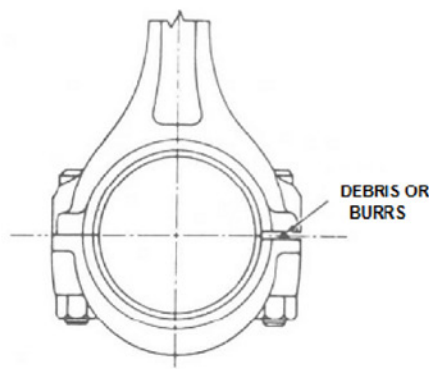
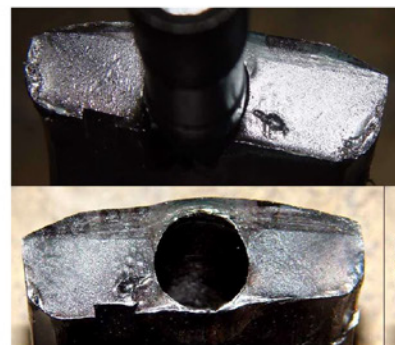
INSUFFICIENT CRUSH

Insufficient crush results in the loss of radial pressure and therefore there is inadequate heat transfer into the bearing housing; this is necessary to avoid the bearing from overheating which causes the deterioration of the bearing material, the consequence of which is evidenced below.

To summarise, insufficient crush may have resulted for any one of the following reasons:-

- Bearing parting faces filed down because it was assumed this would achieve a better fit. Debris or burrs trapped between the mating faces of the bearing cap.

- The housing bore was the incorrect size.
- Fasteners were not correctly torqued during assembly – note the additional information.

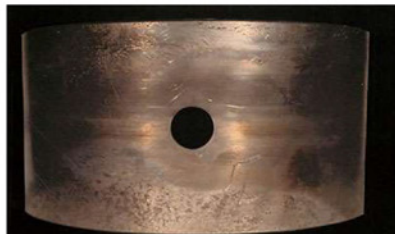
Wear pattern created on the back of the bearing due to the movement.

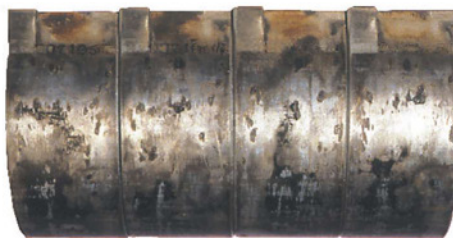
Fretting and polishing due to movement.

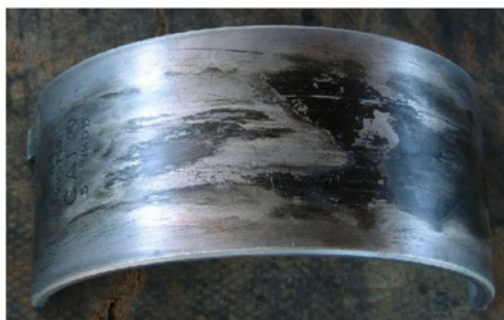
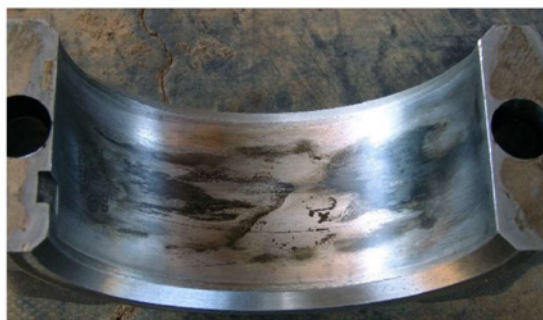
Oil has worked its way into the space between the two surfaces and resulted in these markings.

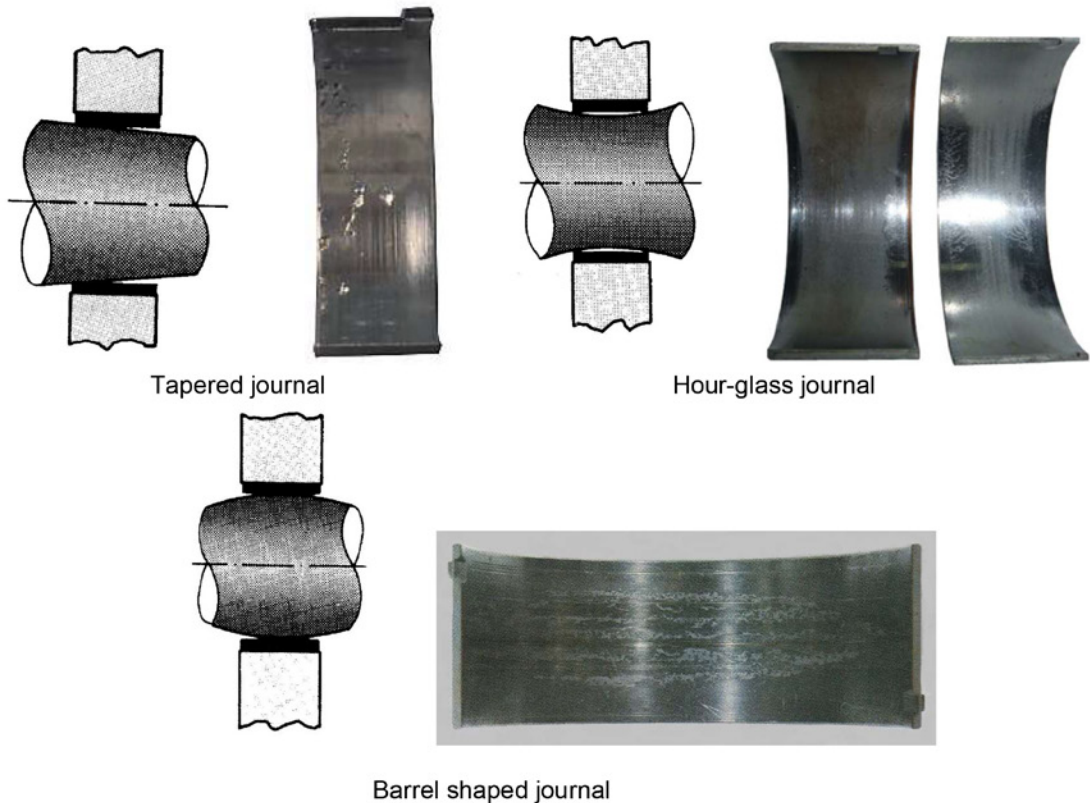
INCORRECT MACHINING

During the regrind of a crankshaft problems can arise which will create unusual wear patterns on the bearings; the ground journal could be tapered, hour glass or barrel shaped.

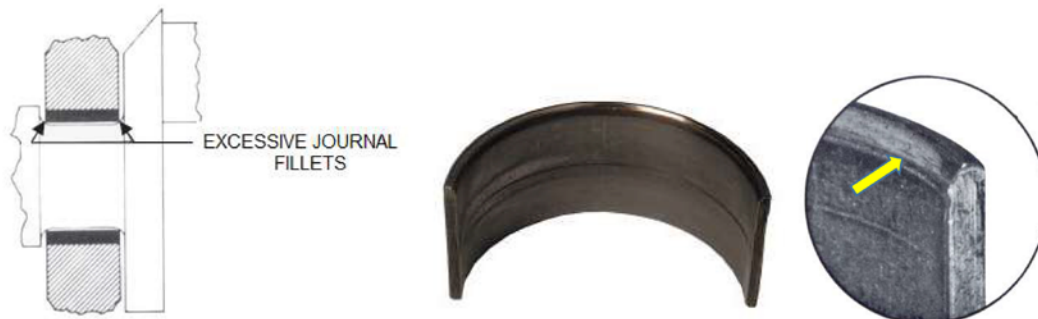
Example of Fillet Ride

When the fillet radius is too big this can cause excessive pressure on the bearing which will result in a premature failure – specifications should be strictly adhered to because too small a radius will weaken the crankshaft in this very critical area.

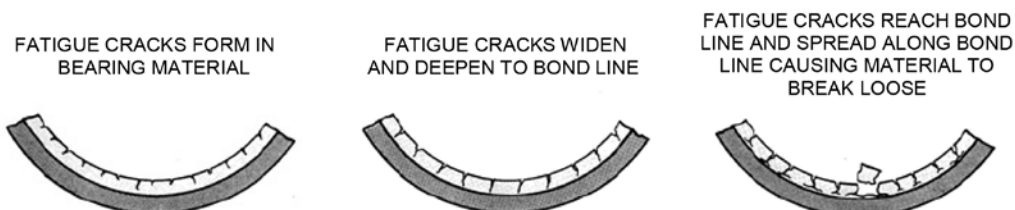
SURFACE FATIGUE

Surface fatigue can occur when the normal service life of the bearing has been exceeded, alternatively, an assembly problem has occurred which has created excessive loading in a localised area and this results in the fatigue of the bearing material.

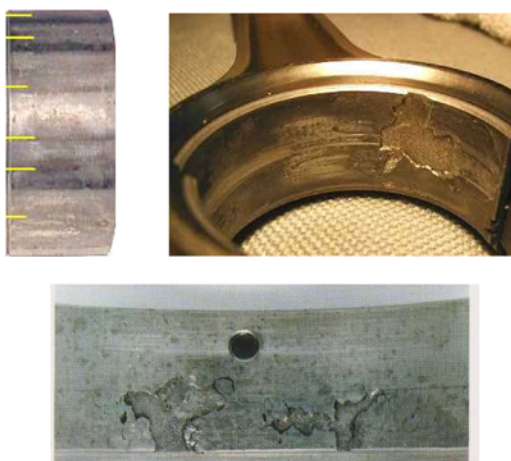
Whilst a bearing bore or journal may appear to be round, there may be deviations from a true round form. These deviations consist of low and high spots which may have been created during a machining process and are referred to as "lobes".

The photographs below show the contact pattern where the bearing pressed against the high spots (lobes) in the connecting rod bore and the resultant damage.

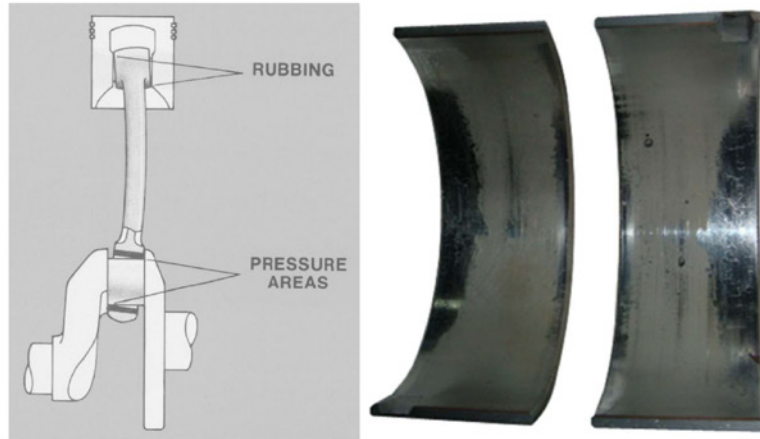
Another possible cause of an unusual wear pattern on the bearing shells can be created by a bent or twisted connecting rod, see below.

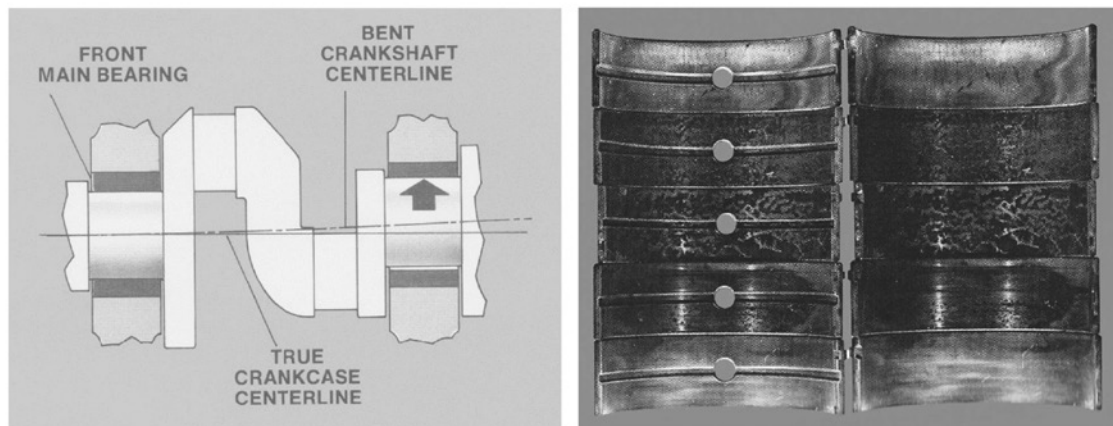
A crankshaft which is bent will also create excessive loading and the resultant bearing damage in the area of distortion; as seen in the photograph damage varies from bearing to bearing.

Note : a similar wear pattern could be created by a distorted engine block.

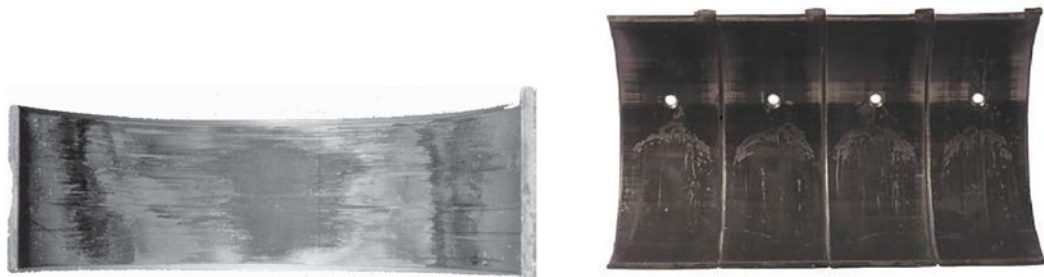
Other possible causes of bearing degradation are CORROSION and CAVITATION both of which are illustrated below.
