# ***KMP BRAND TECHNICAL BULLETIN***

## **Piston Failures - Part 2**

**KB-15003-2**

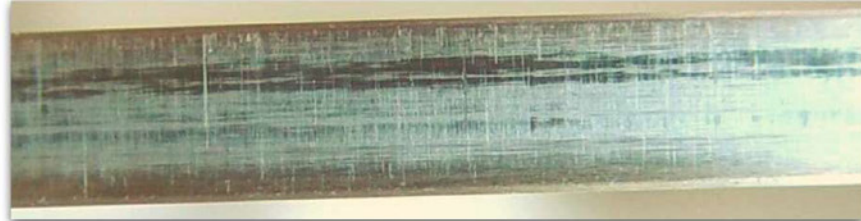
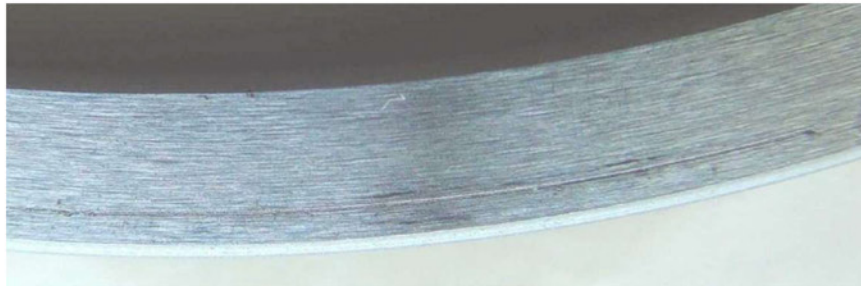
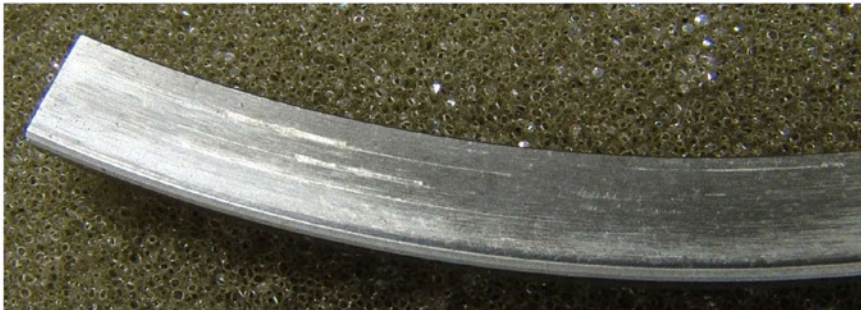
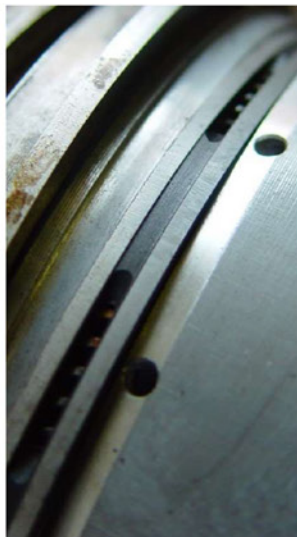
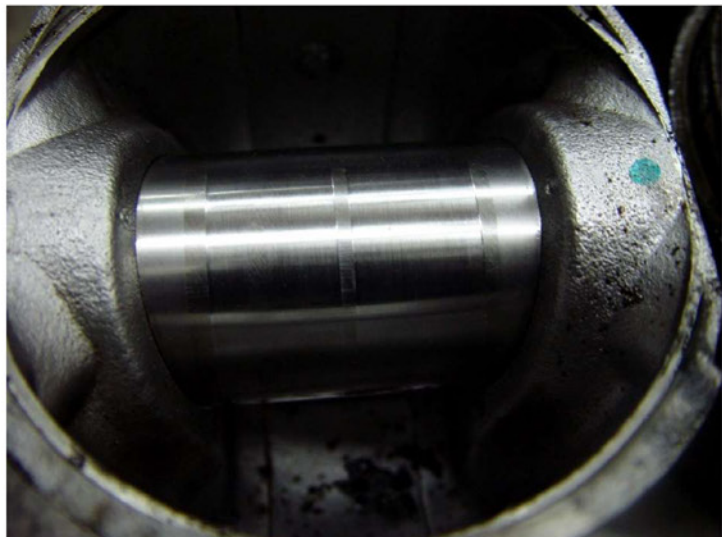
As mentioned previously the piston rings and also the gudgeon pins will also exhibit wear patterns indicating that there was abrasive contamination present whilst the engine was operating.

If failure occurs shortly after an engine overhaul/repair there is a very strong possibility that the contamination was "built-in". The majority of engine parts are lubricated prior to installation, but if the work bench is not clean, there is a possibility that dirt could adhere to a component prior to installation.

Contamination can also originate from the air intake system so it is important to adhere to regular servicing of the filters, and also to check that all connections between the air filter and engine intake are not damaged or loose.

Oil servicing is another possible source of contamination but it is difficult to differentiate between the built-in dirt and dirt introduced with oil; however, if the contamination was introduced via the oil, this tends to cause damage to the crankcase components and the piston skirt below the ring belt and the upper portion of the piston remains relatively undamaged.

If there has been a grinding or honing procedure it is important to make sure all galleries and surfaces are thoroughly cleaned prior to assembly.

If abrasive contamination could be eliminated this would be a major contribution to the prevention of premature engine failures.

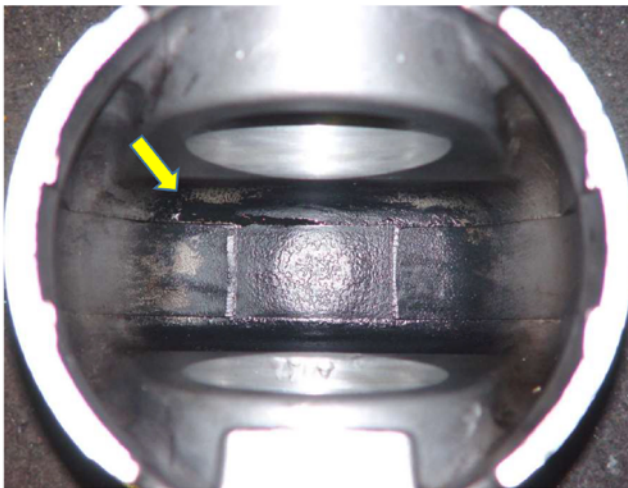
**Lugging** - is when the engine is operated at low engine revolutions with high loading and as a consequence there is a decrease in the volume of fresh air intake which results in piston crown overheating.

**An indication of high combustion temperatures**

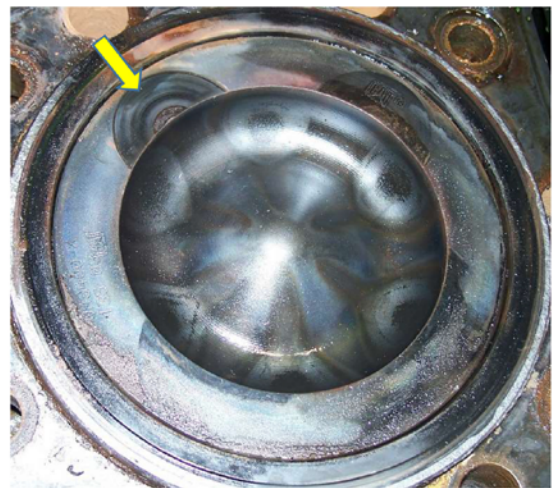
**Over-speeding** - is when the engine is run at more than the manufacturer's recommended rated speed; the higher engine revolutions can stretch the component tolerance "stack-up" which causes the piston crown to contact the valves. The resultant material displacement on the piston crown can then result in the elimination of running clearance between the piston and the liner wall – an adhesion condition would then lead to seizure of the piston.

**Valve head and piston crown contact**

Other possible causes of valve and piston crown contact are - valve timing incorrectly set, excessive connecting rod bearing clearances due to wear or failure, loose connecting rod bolts, or machining of the engine block/cylinder head but the material removal is not compensated for.

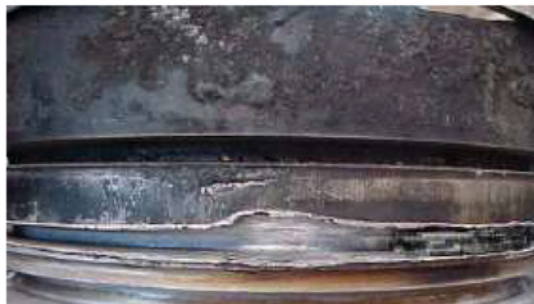
If the type of damage shown in the following photograph is evidenced shortly after an engine overhaul, then there is a very strong possibility that the piston ring was broken when the piston was fitted into the

cylinder. The broken ring erodes away the piston ring land and the area of erosion can soon reach the crown of the piston resulting in a far more catastrophic failure to other engine components.

**Initial damage from a broken ring**

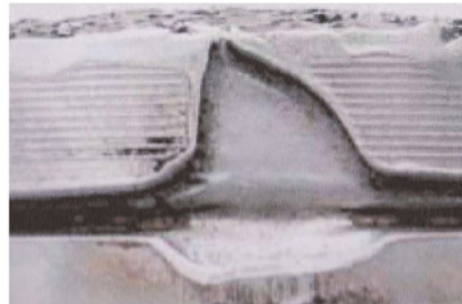
**Progression of damage from a broken ring**

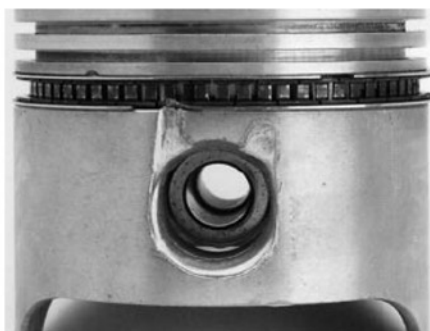
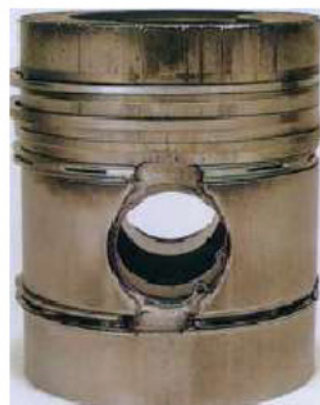
Another area where assembly errors can create avoidable failures is in the installation of the gudgeon pin retainers/circlips. These should never be reused and the new ones should be correctly located in the grooves and should not be distorted during installation. The photographs below show the resultant damage when one of these becomes dislodged.

Besides careless installation there are other possible reasons for this type of failure:

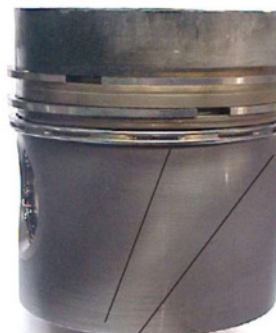
- A bent or twisted connecting rod can cause the gudgeon pin to thrust against one of the circlips and eventually dislodge it. The wear pattern on the skirt will confirm that the piston travel was not straight.

- A crankshaft journal may have been ground with a conical shape, this will also cause the connecting rod to thrust to one side.
- Excessive axial movement of the crankshaft.
- Too much clearance between the end of the gudgeon pin and the circlip.

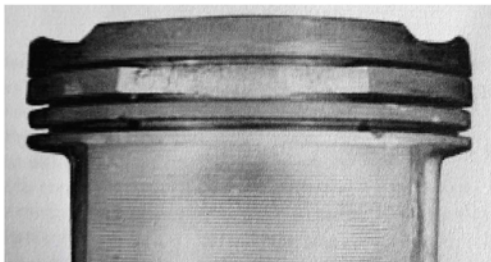
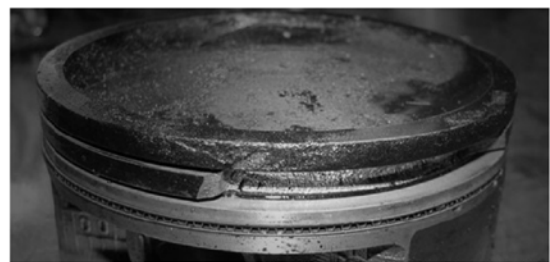
It is often suspected that material faults are the cause of this type of failure, however they occur because of the material being subjected to abnormal loading for which there are three possible causes; abnormal combustion, hydraulic lock or installation error.

The combustion irregularity can result from :

- Delayed ignition of the injected fuel because of insufficient compression.
- Injector nozzles leaking or insufficient injection pressure.
- Too much fuel injected into the cylinder.
- The incorrect use of a starting aid (ether).

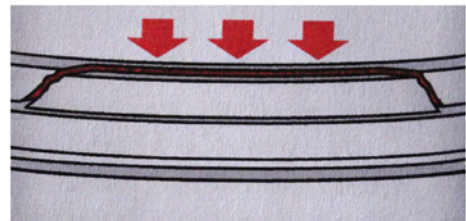
Hydraulic lock can occur when the engine is either stationary or running because any fluid which enters the cylinder cannot be compressed. In a stationary engine coolant could enter the cylinder either as the result of a cracked cylinder head, blown head gasket or liner cavitation which has resulted in the perforation of the liner. Illustration A shows the formation of a fracture as a result of a combustion irregularity or a hydraulic lock. The fracture surfaces extend downwards as a result of the force which has come from above the ring land.

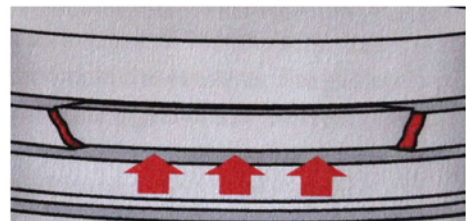
Illustration B

An installation error occurs when the incorrect tooling is used for the installation of the piston into the cylinder. If the rings are not correctly compressed into their respective grooves the protruding ring will hit against the cylinder causing an upward force and therefore creating a fracture of the ring land as shown in illustration B.
