# ***KMP BRAND TECHNICAL BULLETIN***

## **Piston Failures**

**KB-15003**

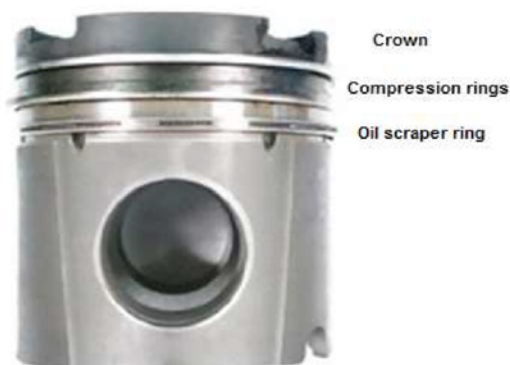
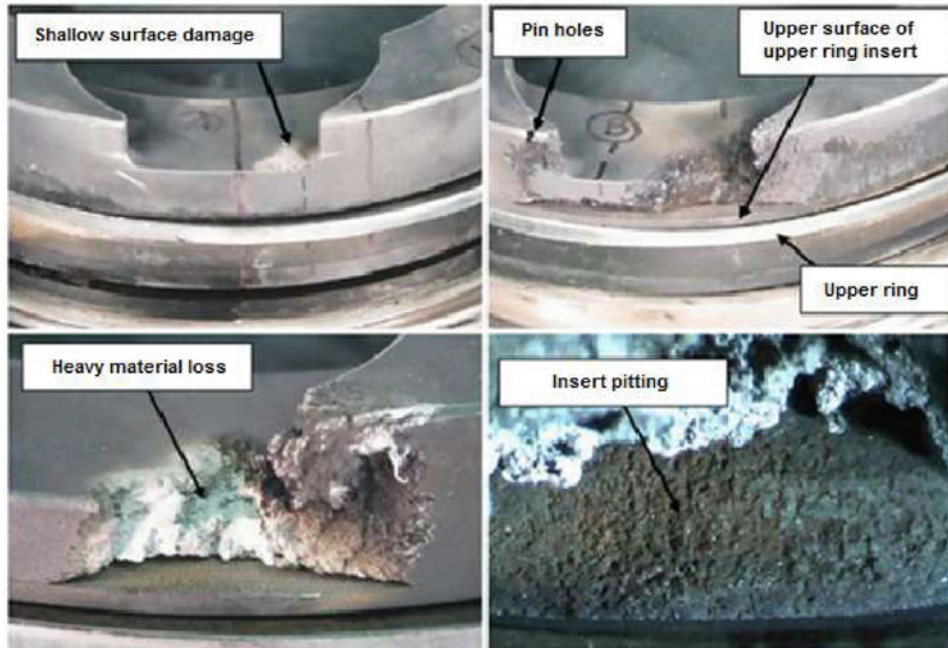
Metallurgical evaluation was performed on two pistons that failed after only 48 hours. The evaluation consisted of visual inspection, metallography, scanning electron microscopy (SEM), and hardness testing.

Piston OD visual damage. Note the heavy material loss working in from the OD, but no ring damage.

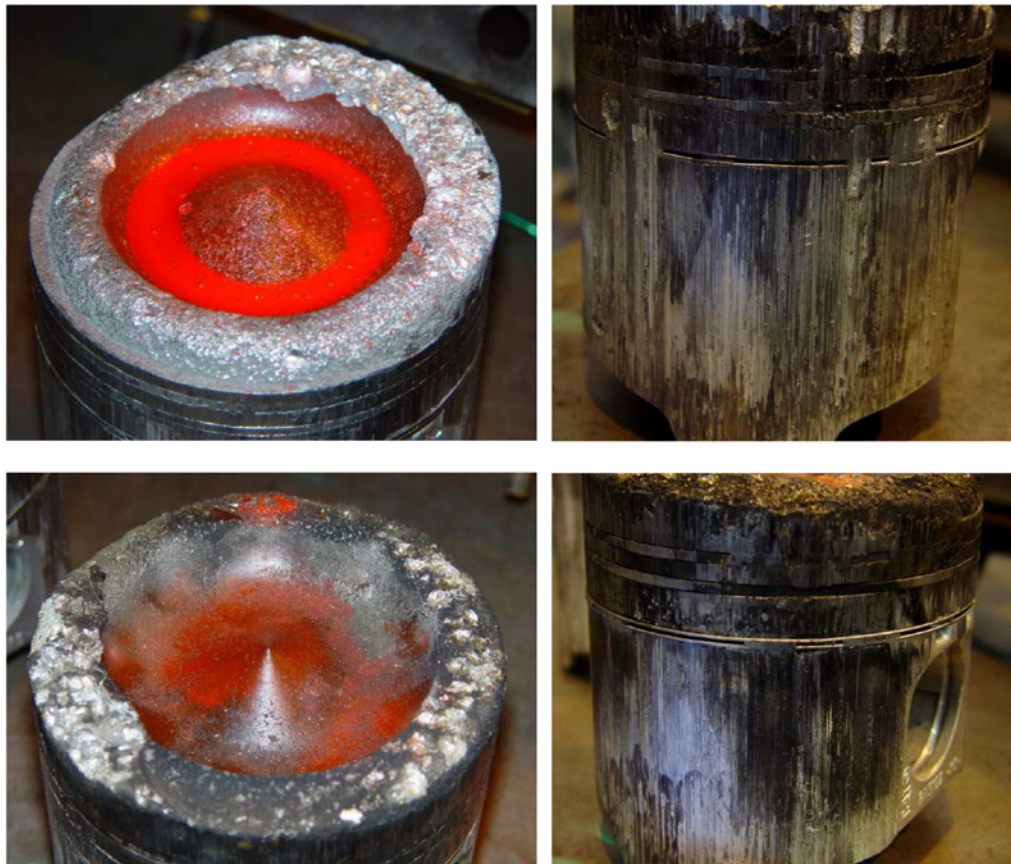
Initially it was thought that a dislodged valve seat had created the damage to the crowns and the displaced material is what caused the damage to the skirts.

Closer inspection of the two pistons and other related components, namely the liners, cylinder head and the valves, revealed that there had definitely been a combustion irregularity based on the observations.

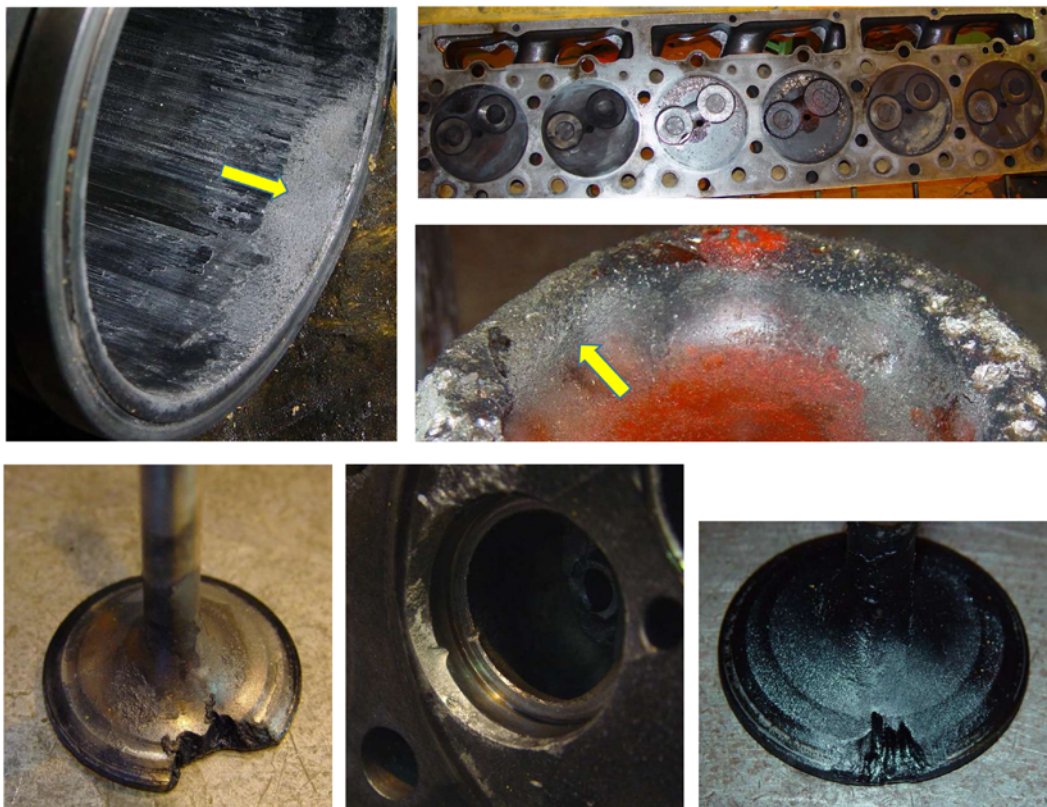
The primary cause of the failure was a combustion irregularity which caused the channelling which was evident on the two exhaust valves; it had resulted in deposits of molten piston material onto the valve seating faces as it was exiting the cylinders, this prevented them from seating properly – as a consequence the channelling occurred.

Valve seats are a shrink fit into the cylinder head, and therefore once the integrity of the seat is affected (in this case by the channelling) the retention is lost and the seat will be dislodged.

The excess fuel then burns and generates so much heat that the melting point of the piston material is exceeded, this combined with the inertia forces and erosive effects of the combustion gases causes particles of the piston material to be torn out, as evidenced in this failure.

Unburnt or incompletely burnt fuel also tends to destroy the lubrication film on the cylinder walls, resulting in damage to the piston skirt and liner bore, and as the failure progresses this reduced lubrication deteriorates even more because of the presence of the molten aluminium which further interferes with the oil film and then severe scoring occurs.

***To prevent unnecessary costs it is important that the true cause of the failure is identified before repairs are carried out.***

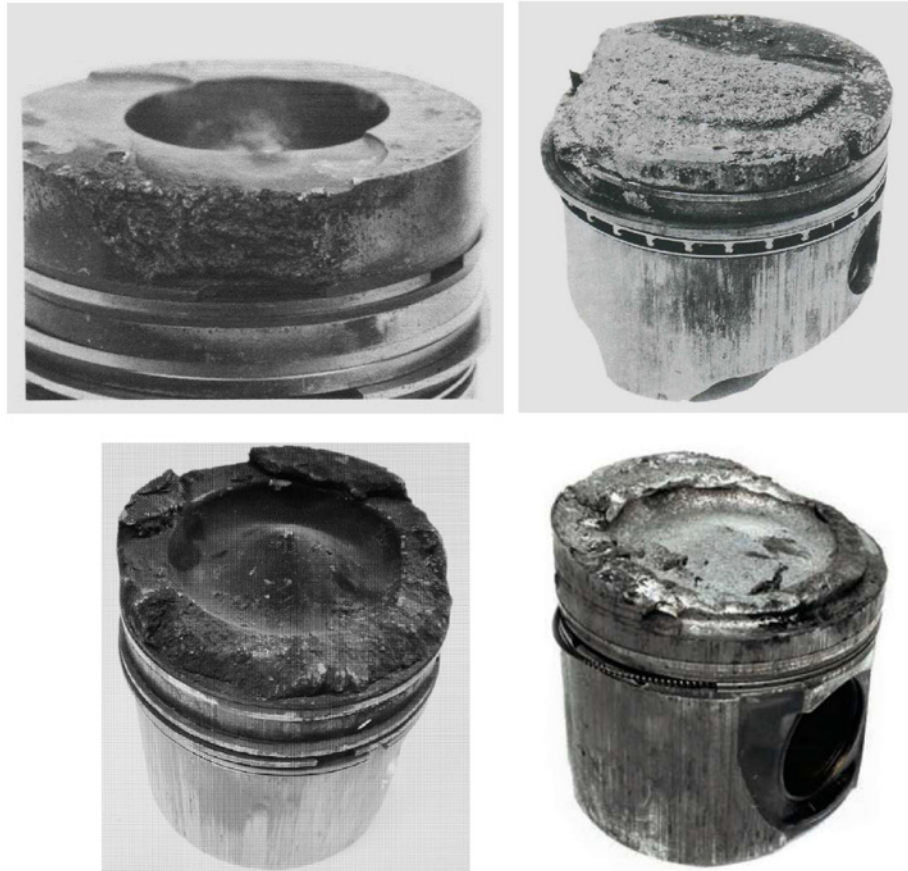
**EXAMPLES OF CROWN EROSION**

It would be wrong to blame the crown erosion on the piston's metallurgy as there is not a piston alloy that would resist fuel burning on its surface.

An assumption that the material was faulty would merely delay identification of the true cause – fuel injection malfunction.

If crown erosion is evident in a diesel engine it is imperative that a thorough check of the entire fuel injection system is carried out.

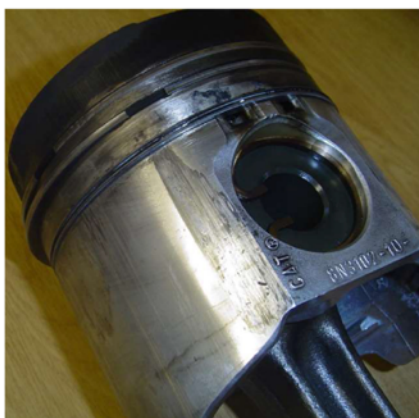
Illustration no.1

**Quarter point scuffing**, refer to illustration no.1

### Quarter point scuffing

Lack of crown cooling by the lube oil - check for misaligned, damaged, blocked or missing piston cooling nozzles.

Low oil pressure – maintain correct oil levels, faulty oil pump or oil relief valve, oil gallery restriction.

Overheating of coolant system - low coolant level, faulty thermostat, faulty water pump, damaged or slipping belts.

Lack of heat transfer in cylinder – aeration of coolant.

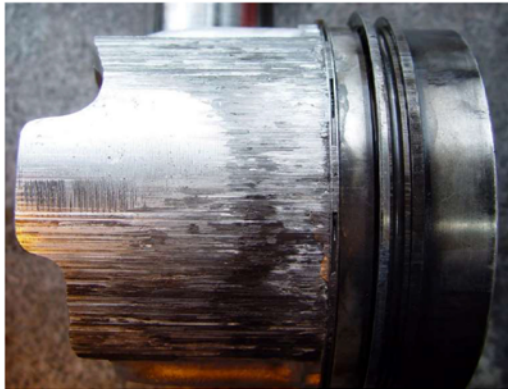
**Illustration no.2****Full skirt seizure**

**Full skirt seizure**, refer to illustration no.2

If all pistons exhibit the same seizure pattern then overheating of the engine is usually the main contributing factor for this type of failure; the possible causes are low coolant level, defective thermostat, defective water pump, damaged or slipping belts, plugged radiator. Alternatively a lack of lubrication could have been the contributing factor because thermal expansion of the piston could have eliminated the film of lubrication, in such cases other engine components should be checked for evidence of insufficient lubrication.

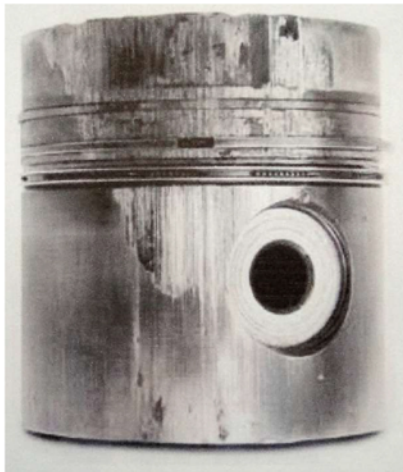
**Illustration no.3****Top land seizure**

**Top land seizure**, refer to illustration no.3

Over-fuelling of specific cylinder – faulty injector or injector timing.  
Lack of fresh air to that cylinder – replace filters at recommended intervals and avoid lugging of the engine which reduces the air intake.  
Exhaust restriction – check for leaking or damaged pipes or faulty exhaust muffler.  
Engine or injection timing – avoid deviations from the manufacturer's specifications.  
Lack of piston crown cooling – check for misaligned, damaged, blocked or missing piston cooling nozzles.

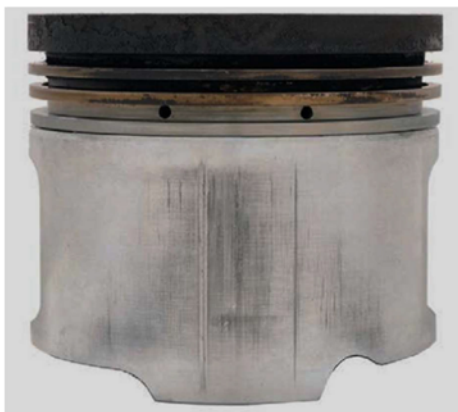
**Illustration no.4****Centre scuffing**

**Centre scuffing**, refer to illustration no.4

High loading on a cold engine – because pistons are not round until the engine reaches operating temperature it is important not to load the engine prematurely.  
Cooling system malfunction – low coolant level, faulty thermostat, faulty water pump, damaged or slipping belts.  
Oil dilution or incorrect grade of oil – faulty injector or injector timing, only use manufacturer's approved lubricants.

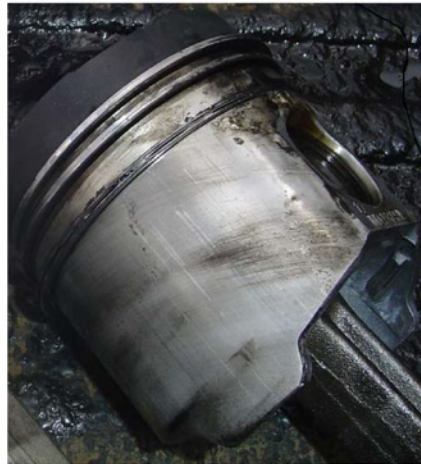
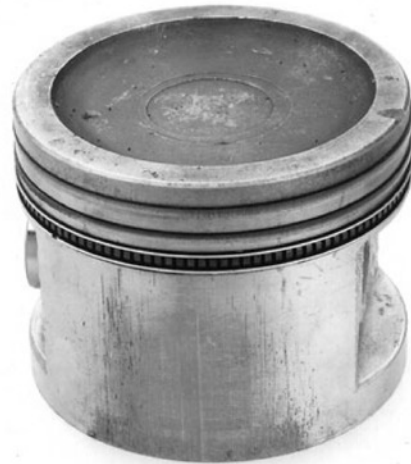
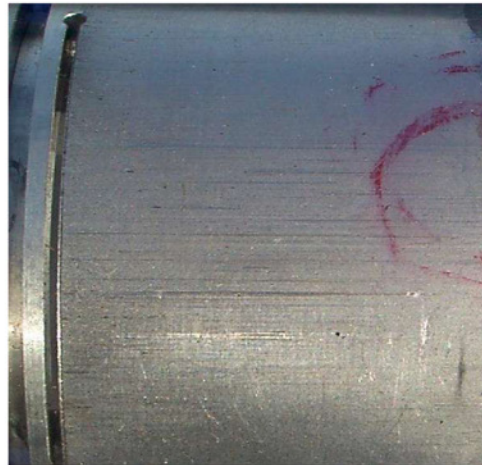
**ABRASIVE DAMAGE**

If it is considered that approximately 45% of piston failures can be attributed to damage caused by abrasive contamination, then a considerable amount of time could be saved by first looking for evidence of abrasive wear.

The piston skirts will have fine dull grey vertical scratches, the cylinder bores will also evidence vertical scratches and there may also be a distinct ridge at the top of the liner where the ring travel ends.

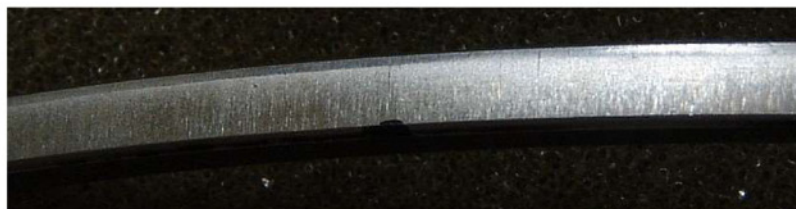
The presence of abrasive contamination can be confirmed by inspecting the faces and sides of the piston rings, there will be fine vertical scratches on the ring face and they will have a dull grey appearance, see the example below.
