KMP BRAND TECHNICAL BULLETIN Piston Ring Failures

The purpose of this bulletin is to illustrate the possible types of damage that could occur when piston rings are subjected to abnormal operating conditions.

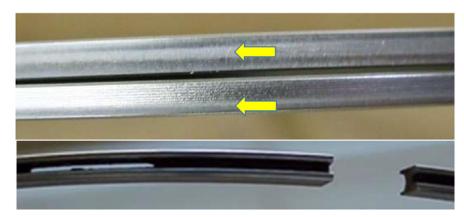
The photographs below show the appearance of three new rings, a barrel faced top compression ring, a scraper second compression ring and the oil ring; the arrows indicate the lapping marks on the ring faces which assist with a more rapid seating of the rings.

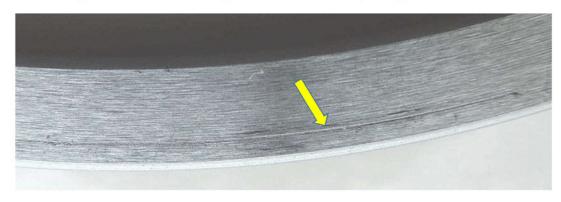
In addition to the wear exhibitted on the outer ring faces there will also be evidence that abrasive particles were also trapped between the lateral ring face and the face of the piston groove.

The bore of the liner as well as the piston skirt will also exhibit evidence that abrasive contamination was present whilst the engine was operating, refer to the photographs above.

The contamination could have originated from a number of sources, either from the air intake system as a result of damaged or poorly fitted pipes, air filters not serviced at the correct intervals or not correctly seated when installed, lack of cleanliness during the assembly process, extended oil/filter servicing or careless practice when conducting the oil servicing.

Wear above the oil ring tends to indicate that the contamination entered from the air intake, whereas wear below the oil ring is an indicator that contamination was probably from the oil.

If abrasive wear has been diagnosed as the cause of the failure then it is imperative that the ring grooves are checked for wear to establish that they are still within specification prior to installing the new rings.
