KMP BRAND TECHNICAL BULLETIN **Turbocharger Failures**

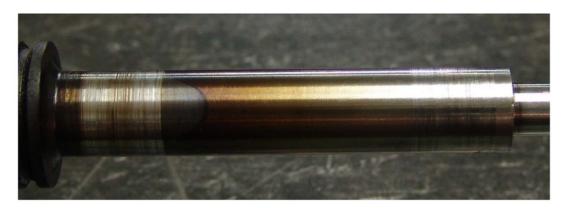
CONTAMINATION OF LUBRICATION

Contamination of lubrication by fine abrasive contaminants will score and wear virtually every bearing surface, but if material particles are large enough, the damage related to the contamination will be more confined to the journal bearing outside diameters and the centre housing bearing bores because the centrifugal force will keep the contaminants away from the spinning shaft.

This is because the majority of the turbochargers have what is termed a full floating bearing/bearings which support the rotating group and have a minimal amount of clearance between components; as a consequence any contaminants in the oil will result in immediate damage to surfaces.

These deposits then contaminate the oil supply and drain lines and the granular carbon deposits become part of the oil supply to the bearings; these will ultimately cause damage to surfaces and increase clearances, which can create a failure very similar in appearance to a lack of lubrication type failure.

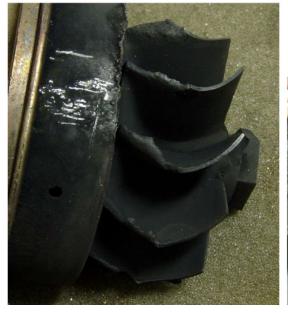
INGESTION OF FOREIGN OBJECT

Ingestion of foreign object can account for as much as 40% of turbocharger failures and the culprit can have a number of origins, a piece of burnt or broken valve exiting the engine through the exhaust will end up damaging the turbine wheel, damaged pistons or piston rings could also be a source.

Other possible sources can be from casting flash inside the cylinder head or exhaust manifold, these could become dislodged over a period of time – in instances such as this the cause of the turbocharger damage will seldom be traced.

The more obvious cause of damage is when loose hardware or other foreign material is left inside the exhaust manifold, air filter housing or the piping – if a nut, bolt or washer is dropped always establish where it fell, better safe than sorry.

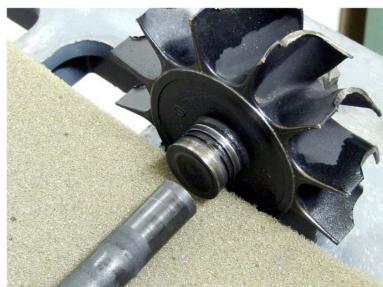
If lubrication is slowed, stopped or interrupted for any reason, metal to metal contact occurs at the journal bearings, shaft journals and bearing bores in the centre housing.

Without the oil, friction will generate enough heat to turn the shaft and bearings blue.

The thrust bearing, thrust collar and/or backplate mating surface will also show signs of damage. Once the bearings and shaft journals are damaged then shaft motion increases and instead of rotating in a perfect circular motion, the shaft begins to oscillate and bearing clearances are enlarged, shaft motion becomes more intense, and damage accumulates.

After shaft motion reaches a certain point, the turbine and compressor wheels will contact their respective housings damaging the blades and possibly backing off the shaft nut.

When blades are damaged by housing rub, the precise balance of the wheel/rotating assembly is destroyed which results in even more shaft motion and ultimately the shaft may eventually break from a combination of motion stress, fatigue and destabilization, and all this can be attributed to the original problem, insufficient lubrication.
