KMP BRAND TECHNICAL BULLETIN

Diagnosing Common Complaints on Cylinder Liners

KB - 15001 PART 2

DIAGNOSING COMMON COMPLAINTS ON CYLINDER LINERS

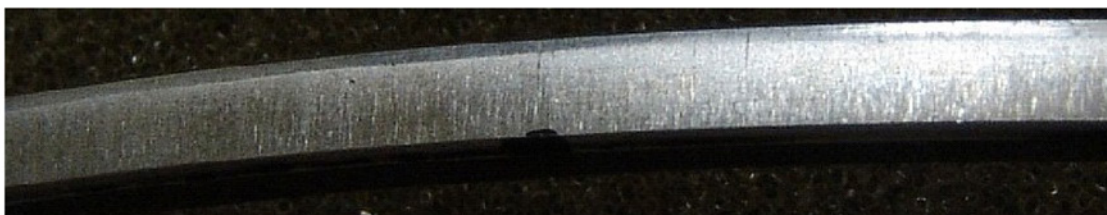
THE RAILS OF THE OIL RINGS HAVE BEEN WORN AWAY, COMPARE THE APPEARANCE WITH A NEW OIL RING SHOWN BELOW

THE FACES OF THESE COMPRESSION RINGS EXHIBIT FINE VERTICAL SCRATCHES

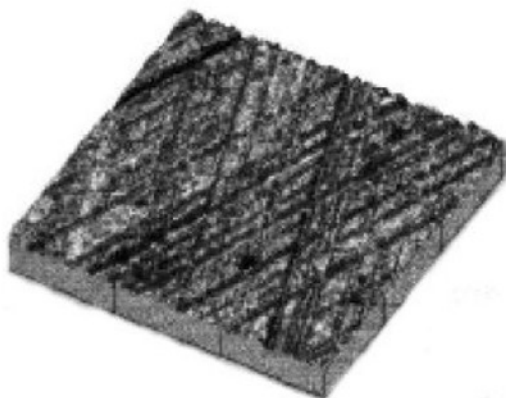
NO POLISHING

When the bore surface becomes polished all peaks and most valleys become worn away, also preventing correct ring lubrication

Below are magnified examples of varying degrees of polishing.

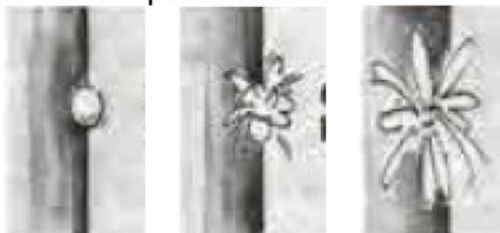
Cavitation erosion is caused by the harmonic engine vibrations which result in the formation of small air pockets between the coolant and the liner (air bubbles) and when they collapse they remove minute particles of the liner.

The first step is to maintain a good coolant condition by adding a suitable coolant conditioner, this is offered by KMP against part number 3P2044.

The correct cooling system pressure is also important; it can assist in reducing the amount of air bubbles that will be present in the system – so another important point would be to eliminate any leaks or replace a loose or leaking radiator cap.

As previously mentioned, cavitation erosion is ultimately the result of vibration, so as a consequence, anything that could cause unnecessary vibrations should be eliminated.
