KMP BRAND TECHNICAL BULLETIN

ENGINE BEARING FAILURES PART 2

KB-15002-2

ASSEMBLY ERRORS

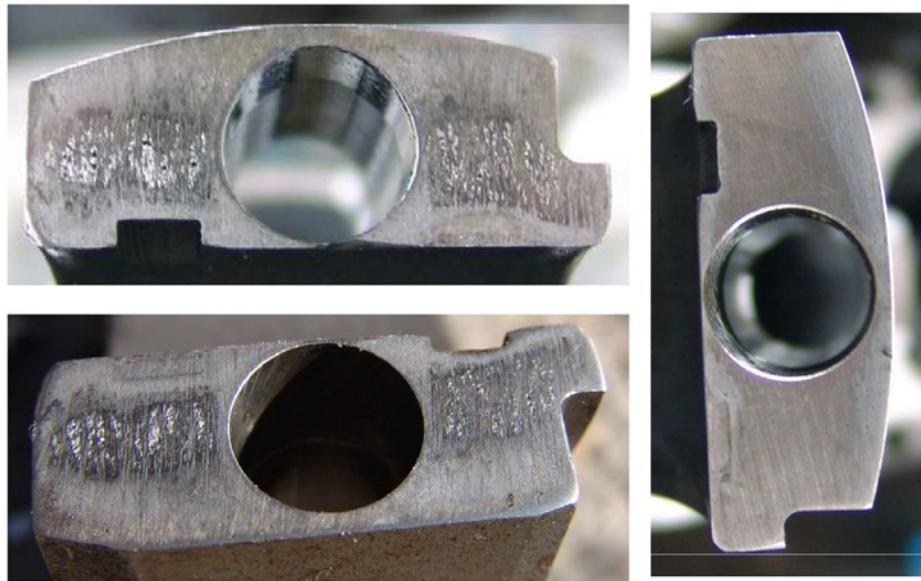
Inspection of the mating faces clearly evidence the presence of fretting (as a result of movement), and the photograph on the right shows the normal appearance of a mating face.
