# ***KMP BRAND TECHNICAL BULLETIN***

## **Piston Failures**

**KB-15003**

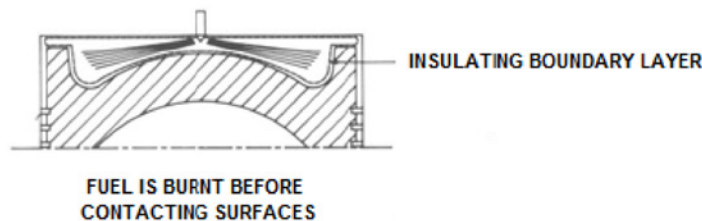
The diesel injection system must meter the correct amount of fuel in an atomised form in the correct spray pattern and at the right time; when all these criteria are met combustion takes place without any fuel being deposited on any of the surfaces. Correct combustion maintains a thin boundary layer of gas which protects any of the surfaces from burning, this is because it provides the thermal protection which is necessary to limit the heat transfer to other components – whilst this boundary layer is very thin (only microns in thickness) its presence is of the utmost importance, see below.
